Independent Expert Review of Certain Girders Manufactured for the Rt. Hon. Herb Gray Parkway

Supplementary Report of Independent Expert Review Committee

October 28, 2013

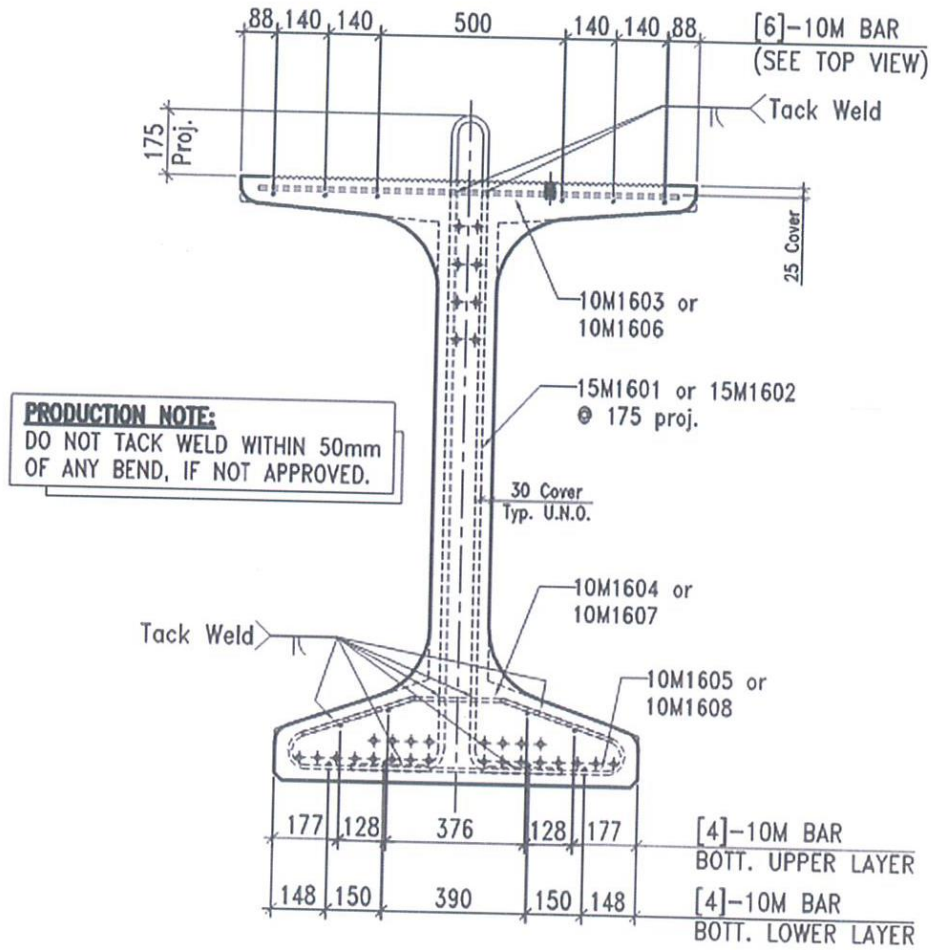
Figure 1. Location of Tack welds in Bridge B15 girder

In a structure containing tack welded reinforcement, the performance at fatigue limit state ("FLS") is absolutely crucial. In its analysis, HMM⁴³ did not check the Bridge B15 girders for FLS at the weld location 4 (See Figure 1 at page 30 below: tack weld location #4 is at the top in the upper flange), stating that the structure is not cracked at that location and fatigue is thus not a concern. This statement contradicts a statement made by HMM in its inspection report (Document No 285380-03-126-0087) on the PSI Bridge B15 girders⁴⁴.

While describing weld location 4, it was stated at page 6 of that inspection report: *"However, cracks in this location are relatively common for two span continuous structures such as B-15, so it was noted that any cracks observed on B-15*

girders in this location might be due to causes other than tack welding".

Furthermore, the report by Anil Mehta of PSI on the conditions of girders shows a large number of cracks in all Bridge B15 and Tunnel T10B girders. Some of the cracks are reported to be 0.30 mm thick and more than 700 mm long⁴⁵.

Figure 2.1: Locations of tack welds in a typical cross-section through B15 girder (extract from PSI shop drawing dated February 7, 2012).

It is recommended that these 8 PSI girders be carefully checked for deficiency in shear reinforcement in accordance with all applicable codes. If the deficiencies are extensive, the girders should be replaced; otherwise they should be strengthened as required. Furthermore, a robust structural health
